# ERRATA FOR IEEE 1394b THREE-PORT CABLE TRANSCEIVER/ ARBITER TSB81BA3, TSB81BA3I (SLLS559) AND TSB81BA3-EP (SGLS194)

SLLZ015C – DECEMBER 2002 – REVISED MARCH 2006

## TSB81BA3 Silicon Errata

This document contains corrections and additions to the following device data sheets: TSB81BA3 (TI Literature Number SLLS559) and TSB81BA3-EP (TI Literature Number SGLS194).

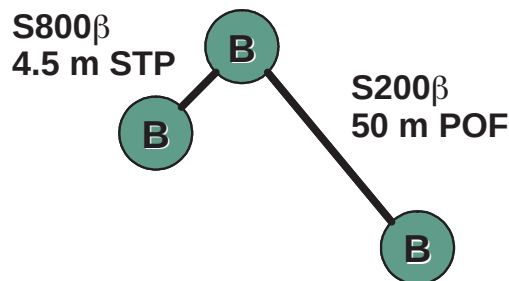
Figure 1. BOSS Arbitration Issue Caused By Mixed Cable Lengths

| SILICON<br>ERRATA ID | PROBLEM DESCRIPTION | RESOLUTION / WORK-AROUNDS |
|---|---|---|
| 2. BOSS arbitration issue | <p><u>Symptom</u><br/>A bus-reset may occur in certain topologies when 1394b BOSS arbitration is in use.</p> <p><u>Occurrences</u><br/>This issue is only possible if three or more BOSS-arbitration capable nodes are connected through a 1394b connection. To be BOSS-arbitration capable a node must have a 1394b PHY and a 1394b Link using the 1394b PHY-Link interface connection.</p> <p>If a narrow timing window is violated (dependent on cable lengths and/or mixed speed bus hops) a middle node may detect a packet collision, causing a PHY state timeout. The state timeout causes a bus reset. Repetitive occurrences result in repetitive bus resets.</p> <p><u>Example Topologies</u><br/>A. Mixing short and long cable lengths. A BOSS arbitration issue may occur in the middle node. Figure 1 shows an example topology that would exhibit the condition.</p> | <p>A. Use one or more 1394a link-layer controllers (LLCs). If the network only consists of nodes using 1394a link layers, then BOSS arbitration is not utilized; Gap_Count delays are maintained and therefore nodes are not affected by this errata.</p> <p>B. In nodes that do not have a link, disable BOSS arbitration (e.g., force the BMODE pin to the logic 0 state).</p> <p>C. Use a topology where all nodes use the same 1394a compatible bus speed (e.g., S400) and at least one IEEE Std 1394a-2000 node is present.</p> <p>D. Use a topology where all 1394B nodes are at the same 1394b bus speed, using matched cable lengths between 1M and 4.5M.</p> |

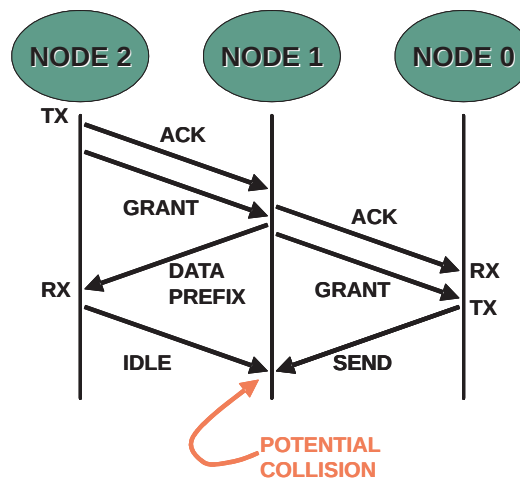
Figure 3. BOSS Arbitration Issue—Detailed Example Situation

| SILICON<br>ERRATA ID | PROBLEM DESCRIPTION | RESOLUTION / WORK-AROUNDS |
|---|---|---|
| 2. BOSS arbitration<br>issue (continued) | <p><u>Detailed Example Situation</u><br/>See Figure 3.</p> <ol style="list-style-type: none"> <li>Node #2 transmits a high-speed packet that ends an Async subaction or the Isoch period.</li> <li>Node #2 advances the Async phase (no requests pending for the current phase).</li> <li>Node #0 has a bus request pending for the new phase.</li> <li>Node #2 sends an Async grant.</li> <li>The Async grant is forwarded through a senior node (Node #1) and down through a junior connection to Node #0.</li> <li>If a narrow timing window is violated the middle node (Node #1) will detect a packet collision, causing a state-timeout while forwarding the grant to the next node. The state-timeout will cause a bus reset.</li> </ol> | |
